## Confidential Inspection Report

LOCATED AT:  
130 Park Blvd #515  
Anywhere, California

INSPECTED ON:  
Friday, March 18, 2022

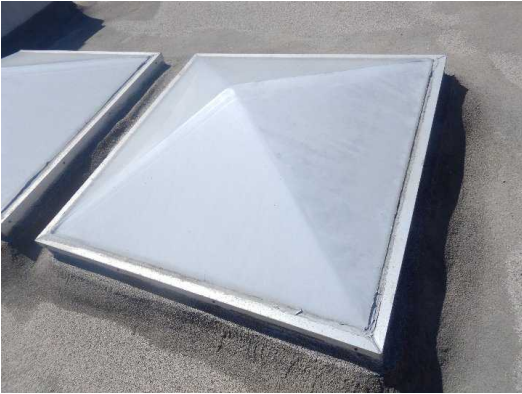
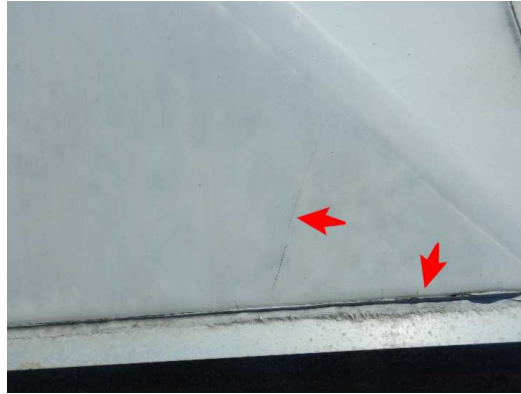
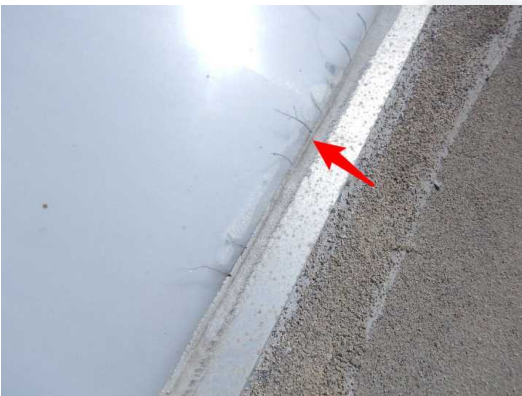
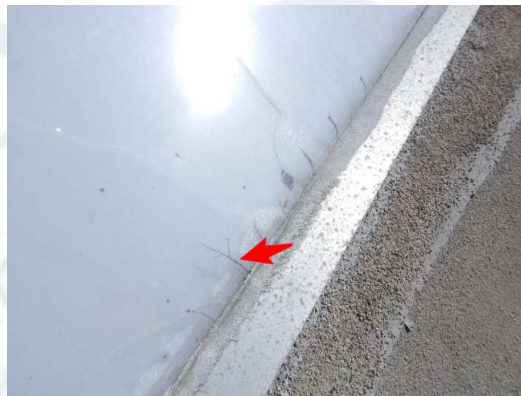
**18:** Attention needed: Some issues were noted that need immediate correction such as cracked/damaged skylight.

Repairs/replacement needed to prevent water entry to interiors or substrate.

More than likely this is a HOA responsibility and should be informed.

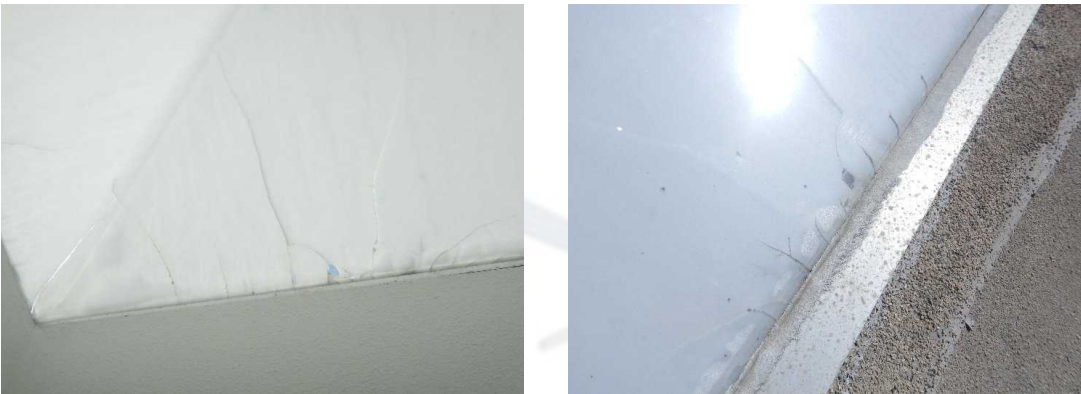
**19:** The skylight needs immediate action as there is some degree of leakage or broken parts.

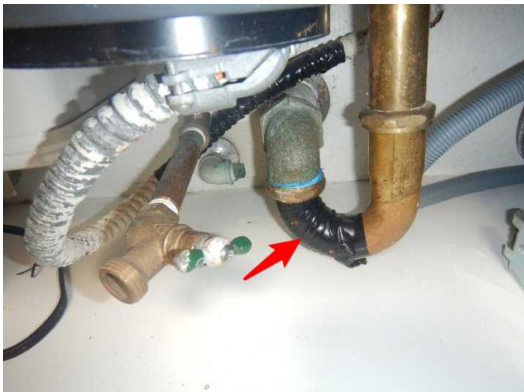
50: Attention needed: There is deterioration of the drain pipes under the sink. Although there is currently no leak, there may be one in the future. When replacing the pipes, I recommend replacing with plastic piping which is not as affected by age and deterioration.

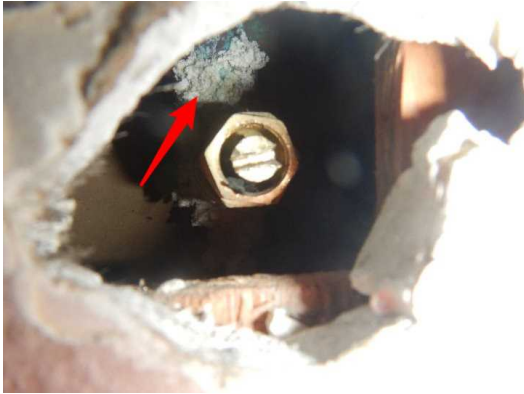
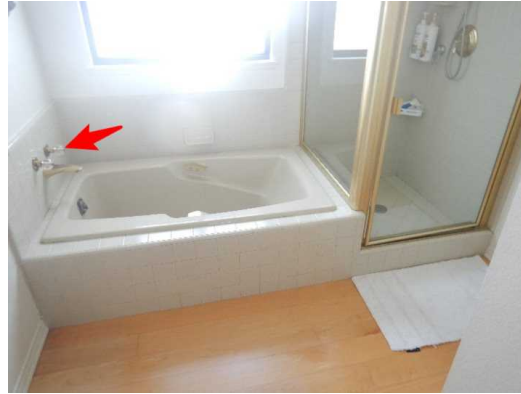
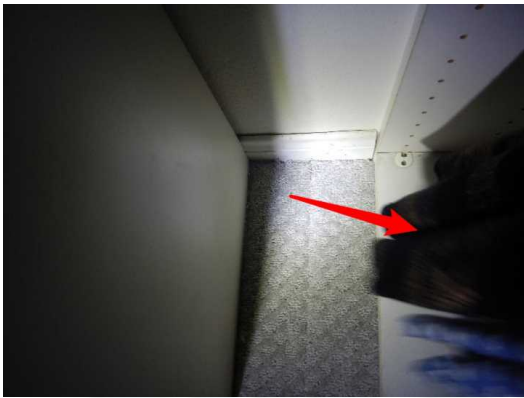
**65:** Attention needed: Tub fixtures and supply lines corroded and hard to operate. Repairs needed by licensed plumber.

Destructive investigation needed in wall behind tub in closet to determine if any water damage and what repairs are needed to supply lines.

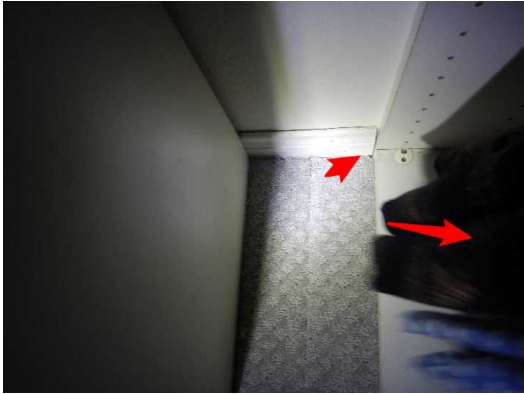
**67:** Attention :Areas of water stains or damage noted, such as; Around the vicinity of tub in master closet. Further evaluation needed.

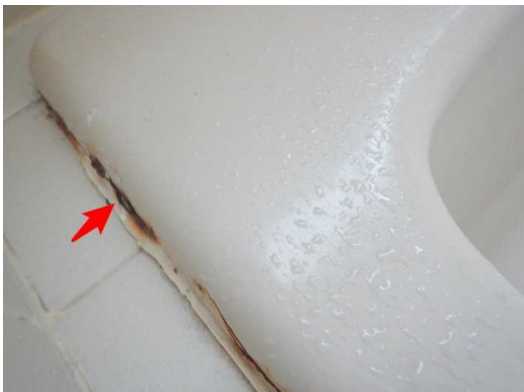
**74:** Attention needed: Rusting and poor seal to tub. Seal to prevent water damage to substrate.

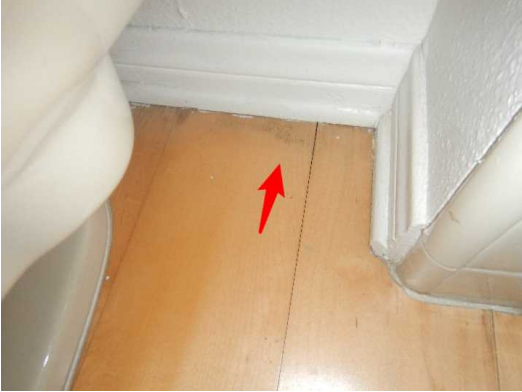
**83:** Attention needed: Water stain or damage noted. Action is necessary to determine the extent of damage and make necessary repairs.

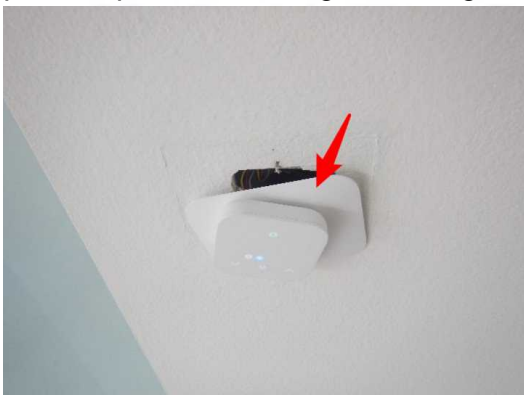
111: Attention needed: Damage/Defects noted. Thermostat not secured to wall. Secure to wall to prevent possible damage to wiring

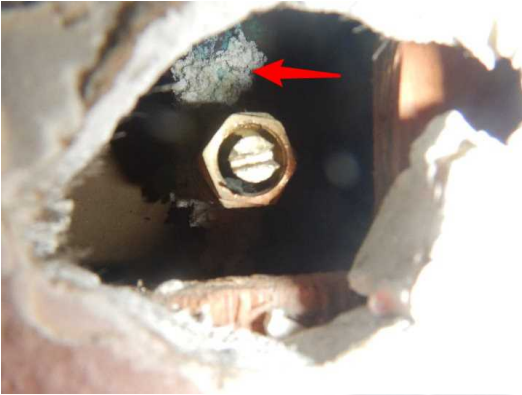
**124:** Attention needed: Corrosion noted to supply lines in wall behind tub fixtures in master bedroom closet. Recommend contacting a licensed and insured plumbing contractor for further evaluation

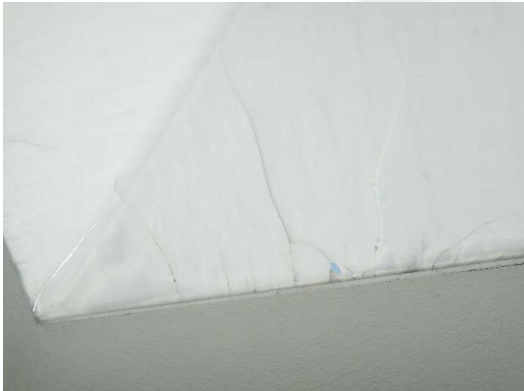
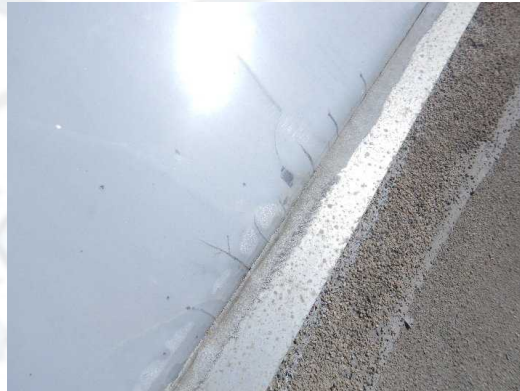
**s-19:** The skylight needs immediate action as there is some degree of leakage or broken parts.

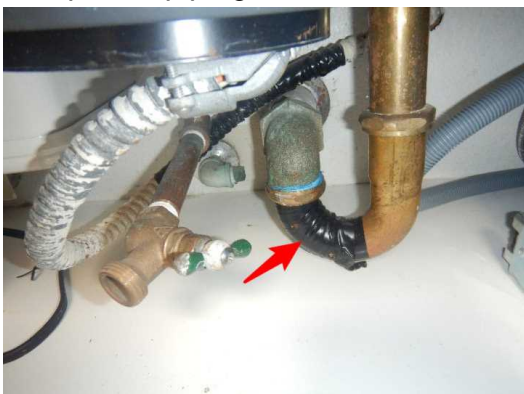
**s-50:** Attention needed: There is deterioration of the drain pipes under the sink. Although there is currently no leak, there may be one in the future. When replacing the pipes, I recommend replacing with plastic piping which is not as affected by age and deterioration.

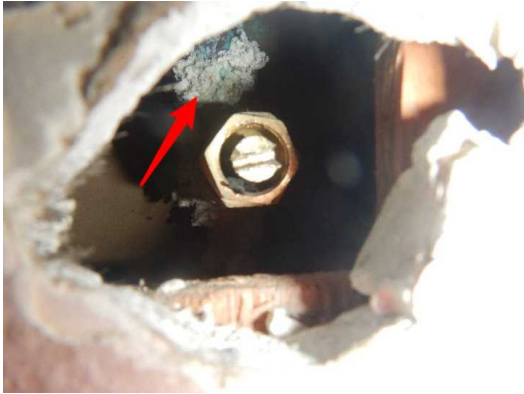
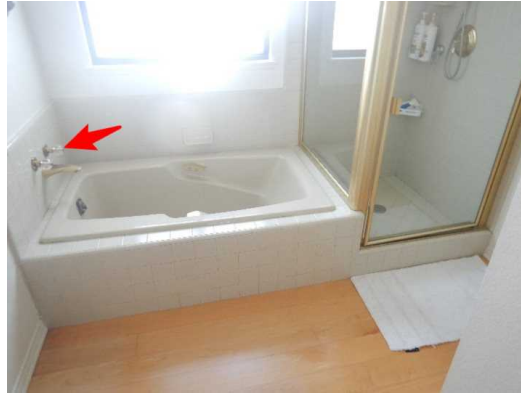
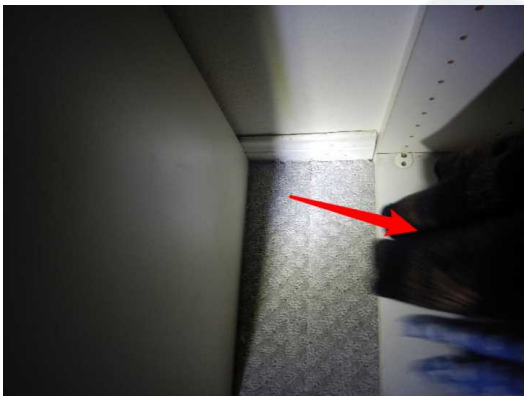
**s-65:** Attention needed: Tub fixtures and supply lines corroded and hard to operate. Repairs needed by licensed plumber.

Destructive investigation needed in wall behind tub in closet to determine if any water damage and what repairs are needed to supply lines.

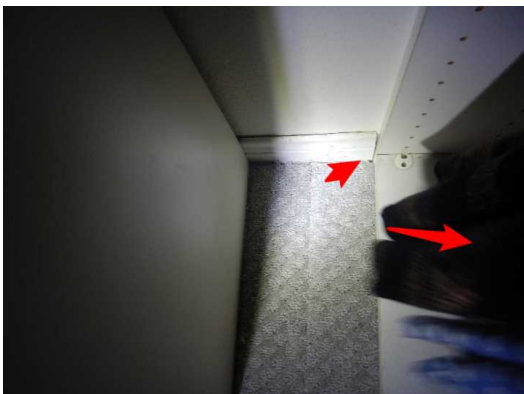
**s-67:** Attention :Areas of water stains or damage noted, such as; Around the vicinity of tub in master closet. Further evaluation needed.

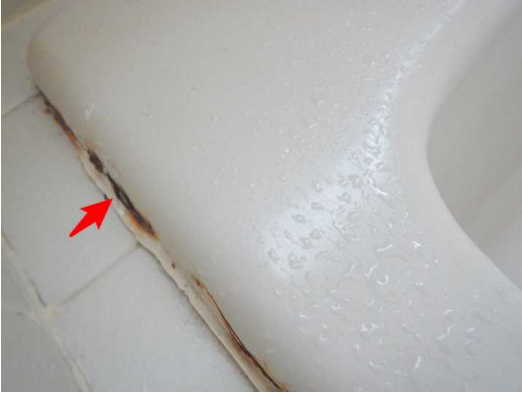
**s-74:** Attention needed: Rusting and poor seal to tub. Seal to prevent water damage to substrate.

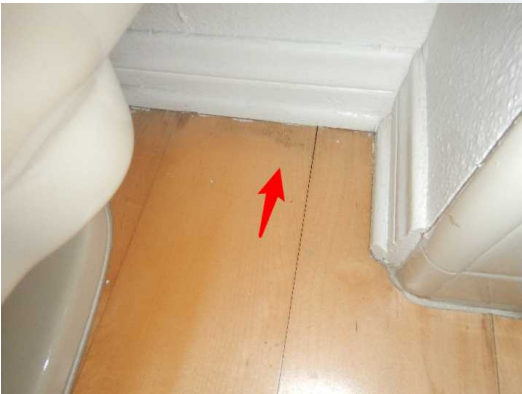
**s-83:** Attention needed: Water stain or damage noted. Action is necessary to determine the extent of damage and make necessary repairs.

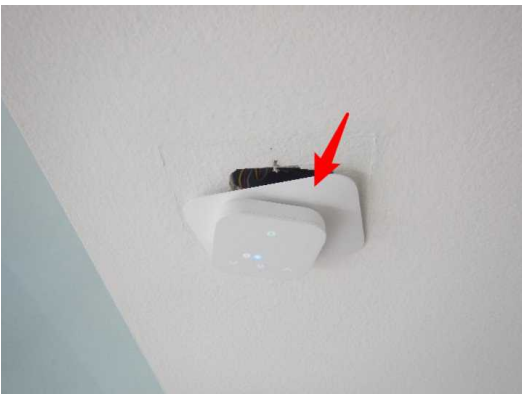
**s-111:** Attention needed: Damage/Defects noted. Thermostat not secured to wall. Secure to wall to prevent possible damage to wiring

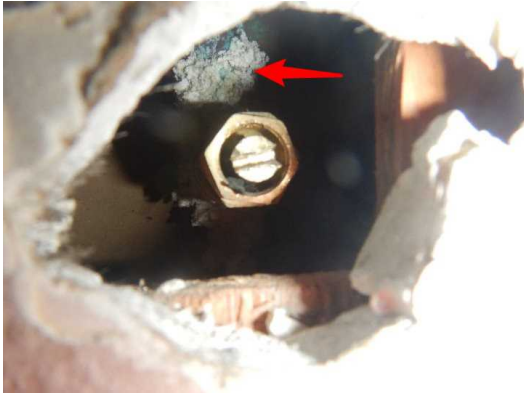
**s-124:** Attention needed: Corrosion noted to supply lines in wall behind tub fixtures in master bedroom closet. Recommend contacting a licensed and insured plumbing contractor for further evaluation
