Confidential Inspection Report

LOCATED AT:
2166 Your Home Dr.
Pasadena, California 91107

INSPECTED ON:
Saturday, August 26, 2023

Inspector, Jerry Holt
Brooke And Sons Inspections

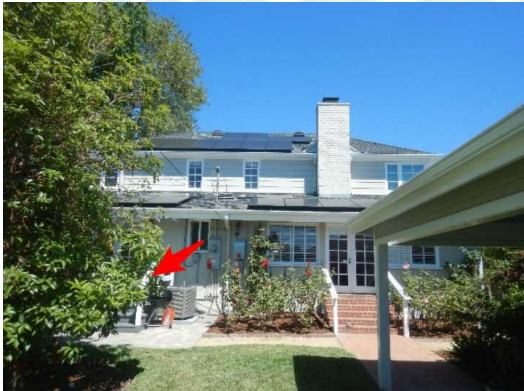
41: Client should be aware that hand railings are not constructed to industry standards. Ideally had rails would allow for easy hand grip.

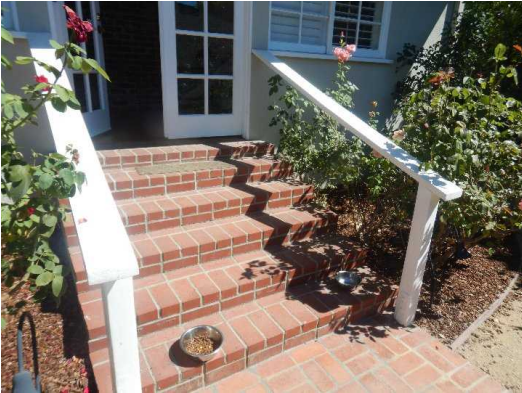
47: Attention: Client should be aware that hand railings are not constructed to industry standards. Ideally had rails would allow for easy hand grip.

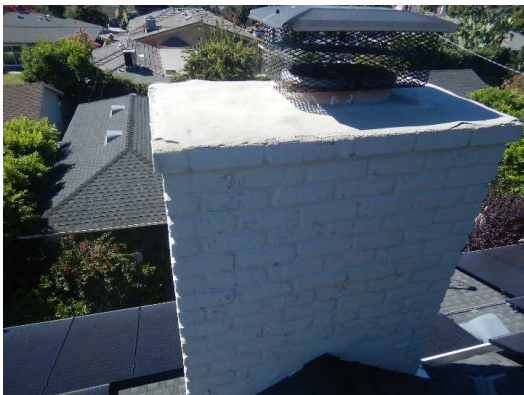
53: The exterior fireplace stack is made of mortar and brick.

54: The exterior stack is in satisfactory condition.

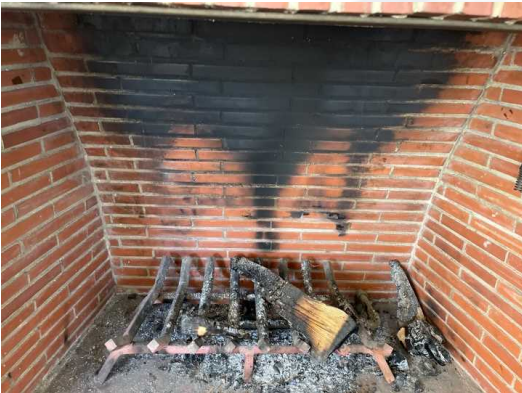
60: Satisfactory

61: There are no glass doors installed. These could help minimize heat loss from the room when fireplace is not in use. When the fireplace is in use, they will eliminate embers from flying into the room and reduce the volume of room air sucked up the chimney.

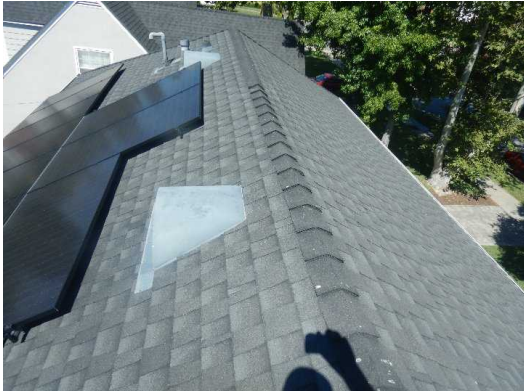
66: Hip

67: Fiberglass composition shingles. Fiberglass mat, asphalt impregnated. Shingles are applied in horizontal rows.

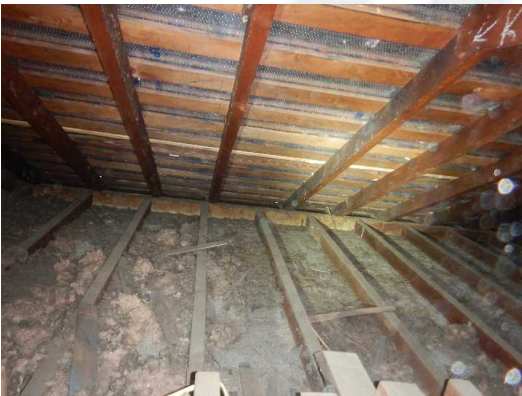
78: A rafter system is installed in the attic cavity to support the roof decking.

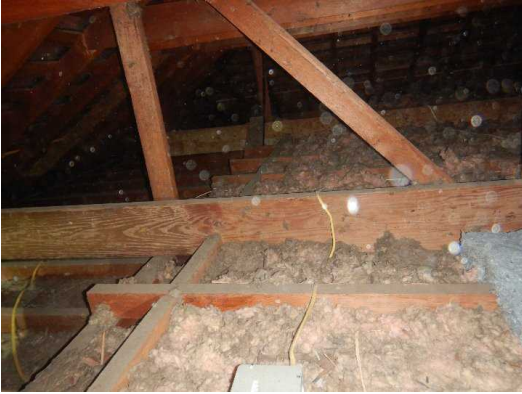
82: The following type of insulation was noted in the attic: Fiberglass. Loose bagged or blown in place.

83: There is an average of at least 4" of insulation installed.

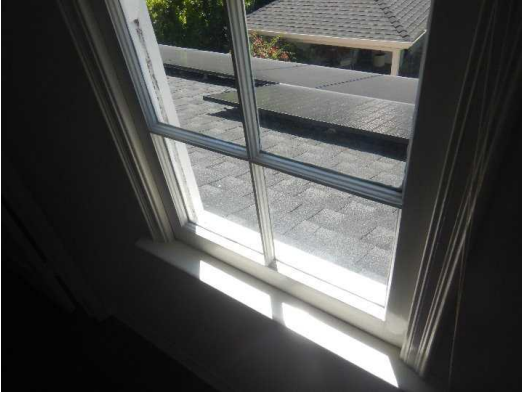
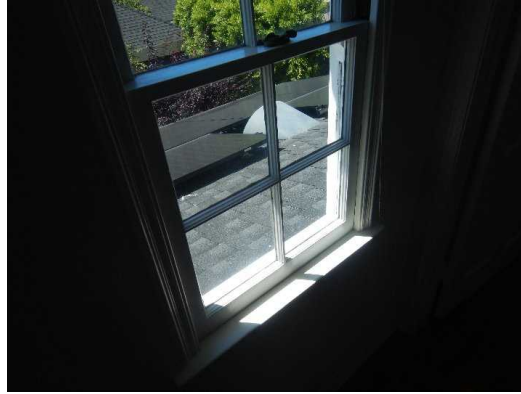
87: Some of the windows are painted shut and do not operate. Repairs are needed as this does compromise safety egress and hinder ventilation.

88: Some of the windows do not operate. Repairs needed

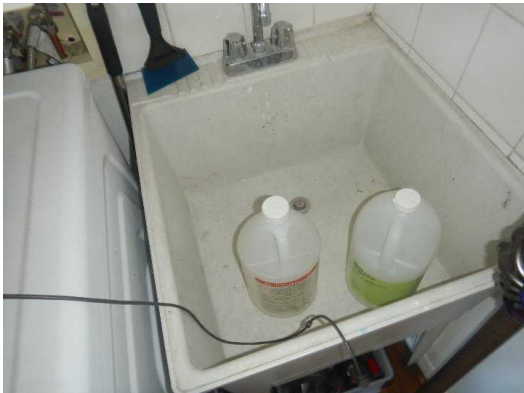
99: There is a laundry basin installed. The unit is functional. No leaks were noted.

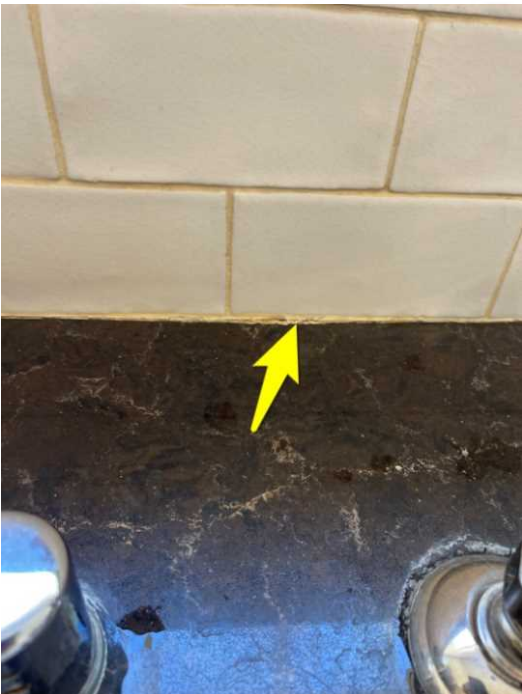
103: Attention needed: The caulking in water contact areas appears to need attention, such as along where countertop meets splash wall. If left unsealed, water can cause costly damage.

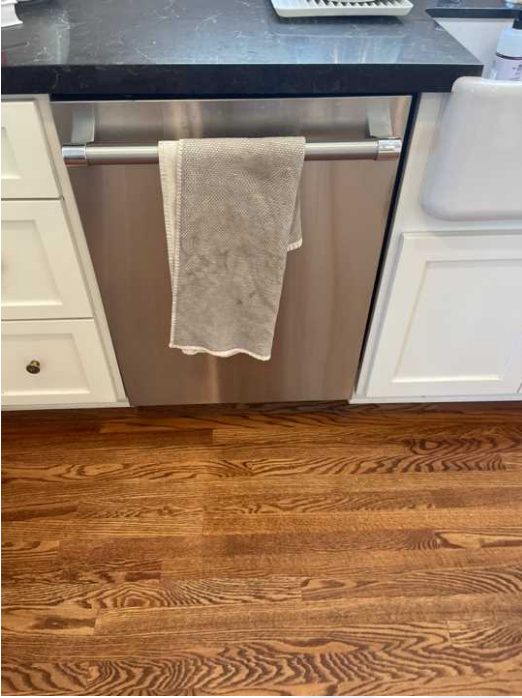
111: Operational at time of inspection. Operated on one cycle only.

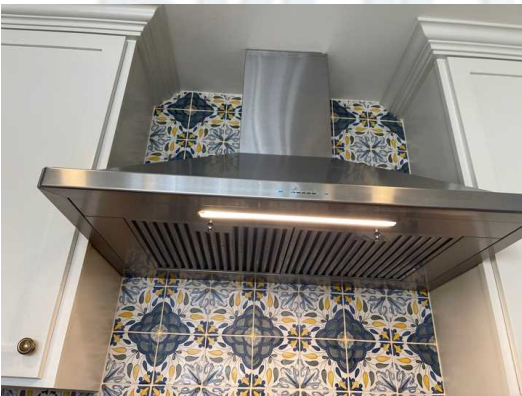
112: The range hood and exhaust fan appeared to work correctly on one or both speeds. There is a filter installed, and it will require periodic cleaning.

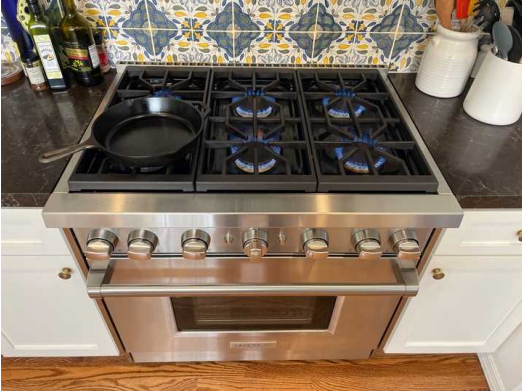
113: Free Standing - There is a removable gas range/oven installed. It appeared to function correctly at the inspection. The timers and temperature settings were not tested and are not a part of this inspection.

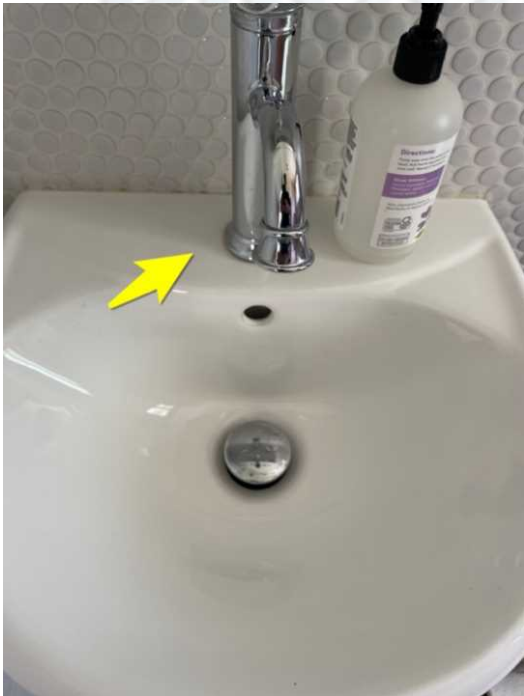
117: Sink fixture loose. Repairs needed.

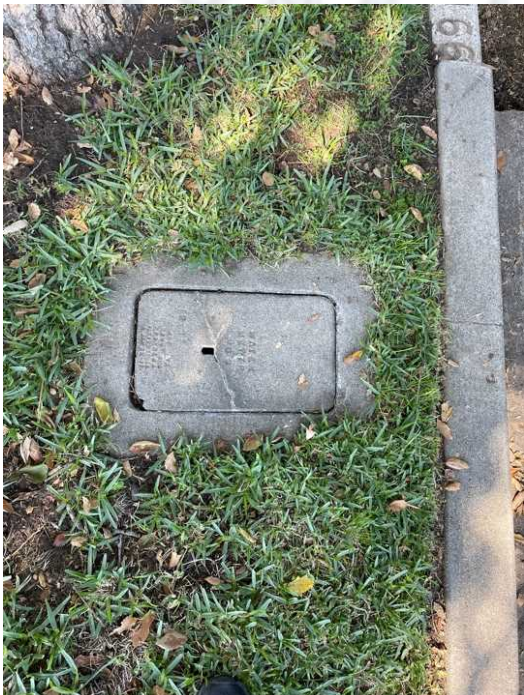
157: Meter is located at Front parkway

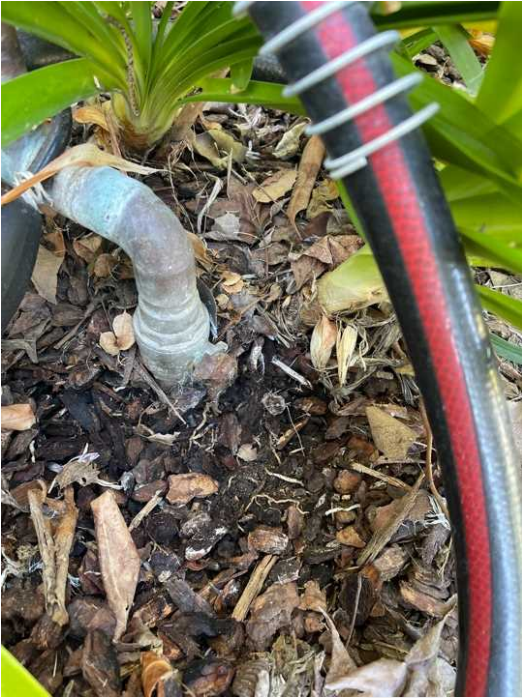
158: Shut off valve is located at front of building

159: Main service shut off should be located in an accessible location to facilitate operation in the event of an emergency.

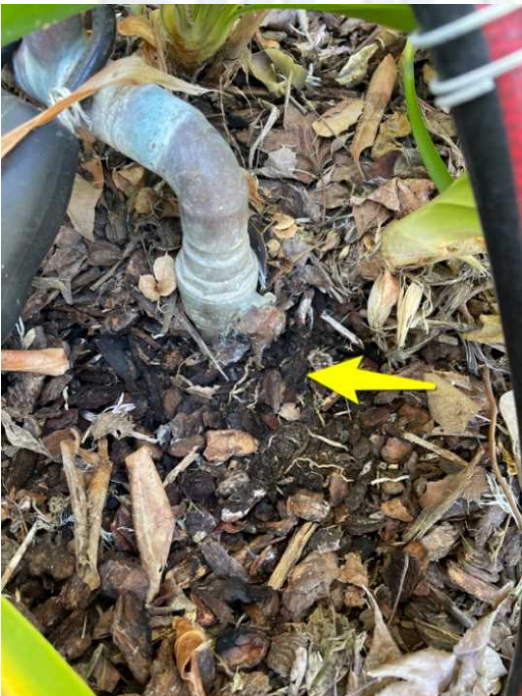
Valve buried in soil. Improvements needed.

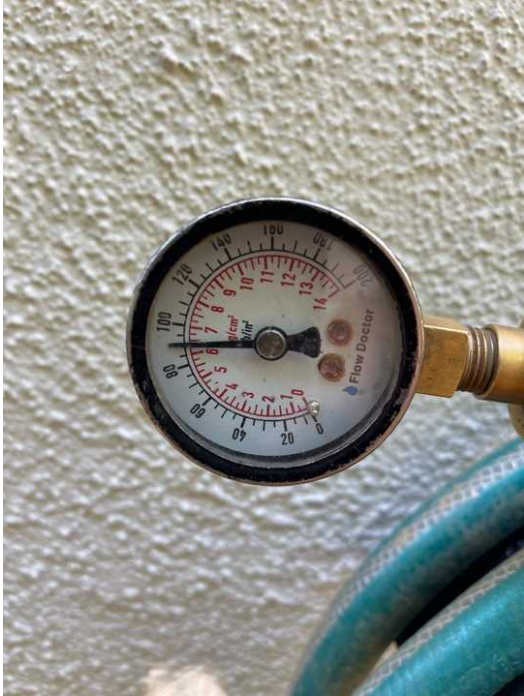
161: Attention Needed - Water pressure was over 80 pounds per square inch and is considered excessive. Suggest the supply should be adjusted to below the 80 pound maximum. If the supplying utility company cannot adjust the pressure for you, then a water pressure regulator valve is recommended.

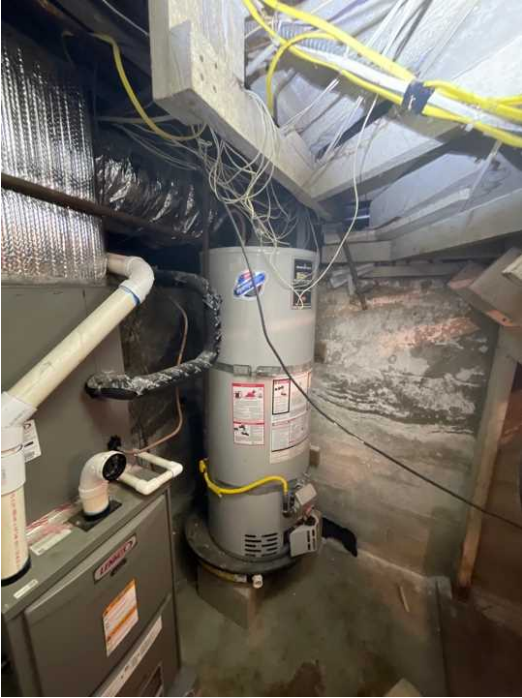
173: Basement

174: 17 years old, 50 gallon natural gas fired. Average life span of a water heater is 12 to 15 years.

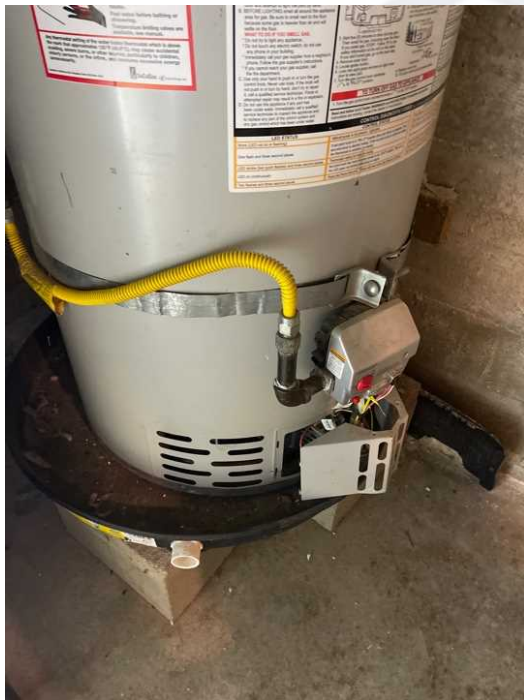
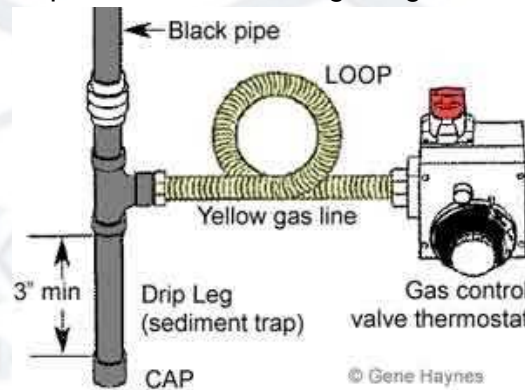
178: No - There is no drip leg/sediment trap installed on the incoming gas line to the water heater. Installation of a drip leg is recommended to prevent debris from getting into the gas valve.

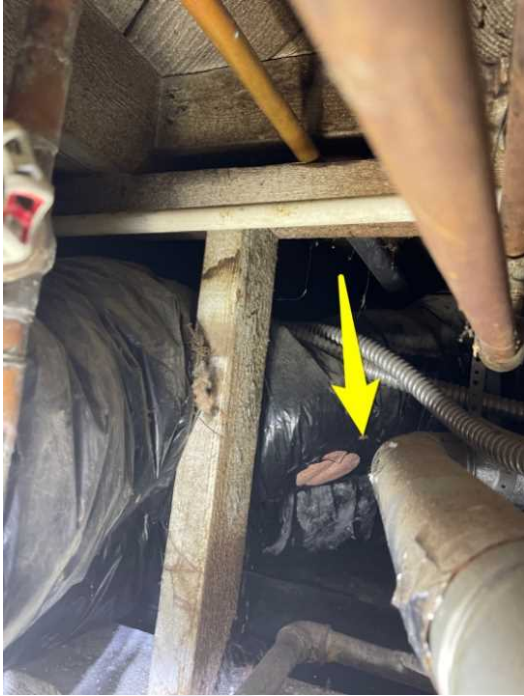
180: Unsatisfactory: There is inadequate clearance from flue pipe to adjacent combustible product. Corrections are needed as this is a potential fire hazard. Have licensed plumber remake corrections.

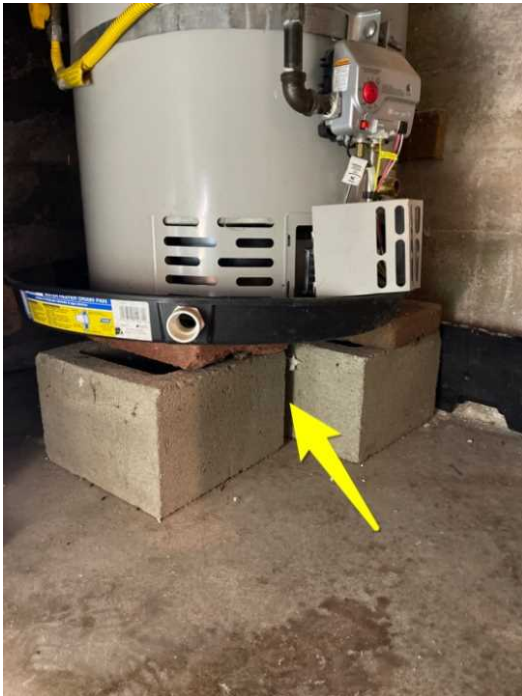
188: The platform that this water heater rests on should also be anchored to the structure to prevent movement

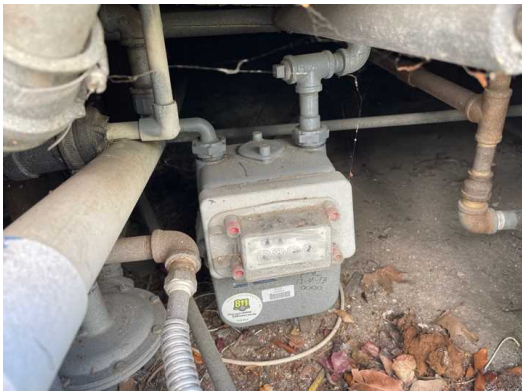
189: Right side Crawlspace

190: An automatic seismic gas shut off valve is not installed
Los Angeles City Ordinance 174478 requires that seismic gas shut-off valves be installed on designated buildings within the City. Seismic gas shut-off valves are designed to automatically shut off the supply of natural gas to a building to prevent a fire or explosion due to accumulation of gas in the building in the event of a major earthquake.

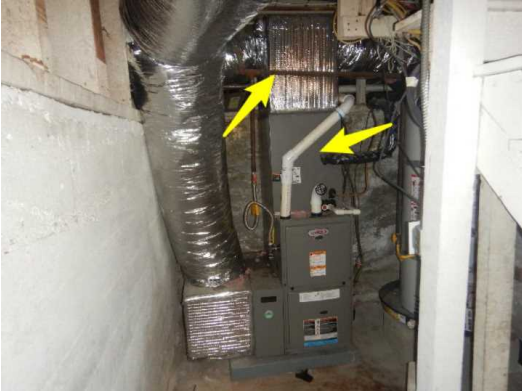
202: Attention needed: Water was seek leaking from ducts in lower level crawlspace. Inspector suspects water is coming from interior fan coil. Further evaluation is needed by licensed HVAC technician to its cause.

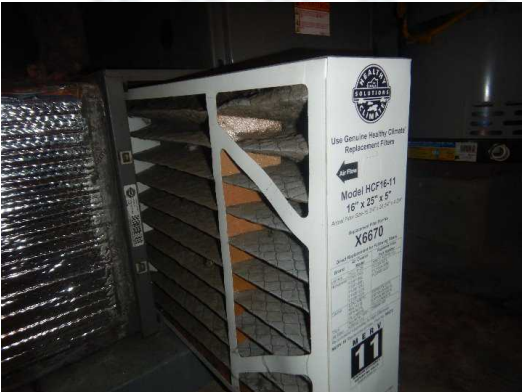
205: The filter is clean and correctly installed. It is recommended that the filter(s) be changed or cleaned every 30 to 45 days for best performance..

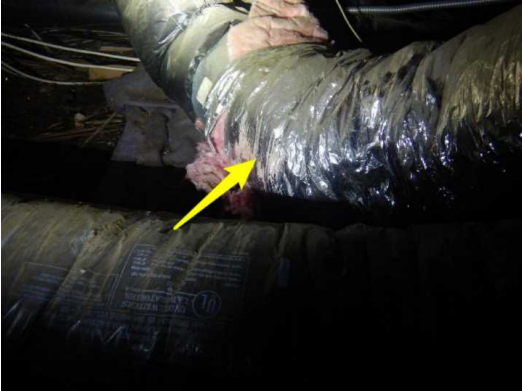
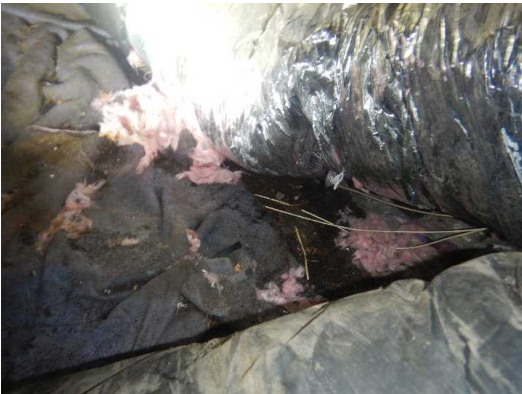
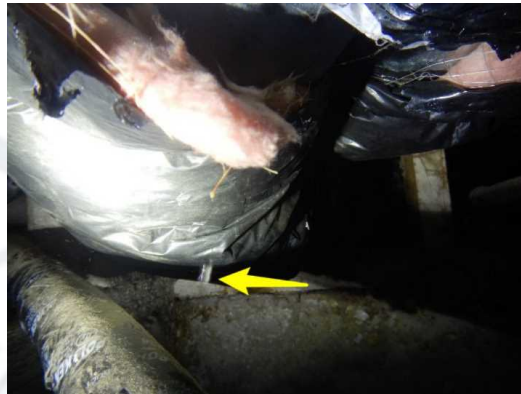
220: Unsatisfactory - Some of the ducts for the lower floor need to be replaced due to high water content inside of them. Further evaluation and repairs by licensed HVAC contractor to determine cause of water in ducts.

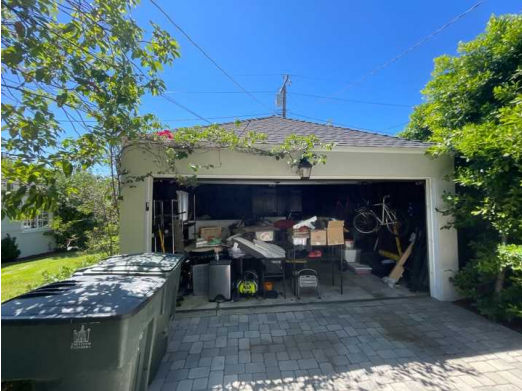
221: The garage is detached and free standing.

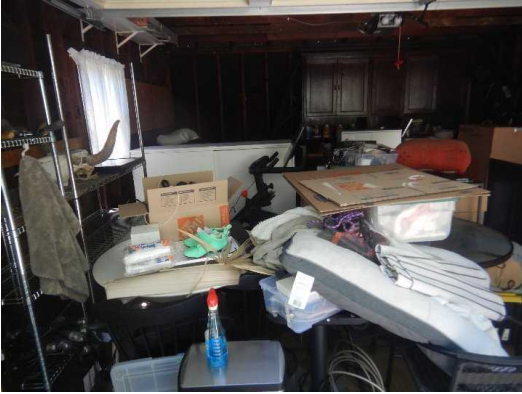
228: Due to stored items on the garage floor, I was unable to determine the condition of the portions of the floor that are not visible.

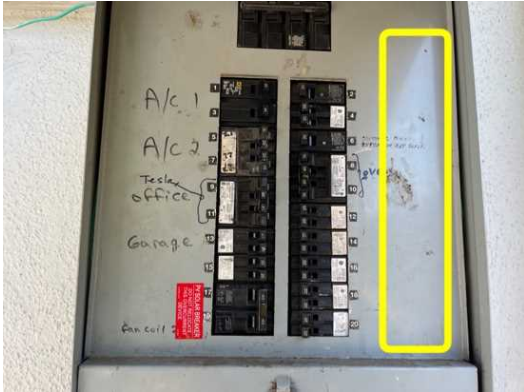
245: The breakers are not marked as to the rooms, areas, or appliances controlled. It is recommended that they be noted as soon as possible.

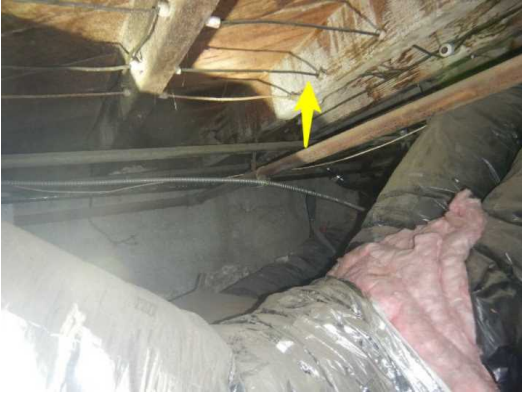
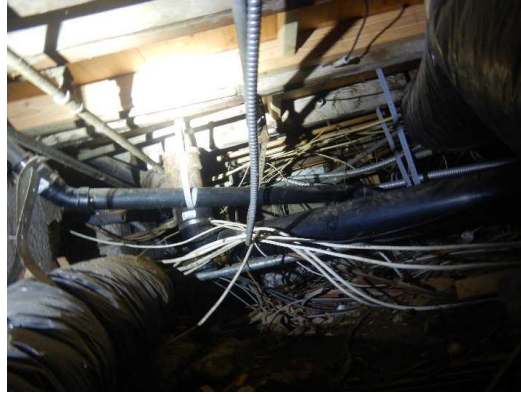
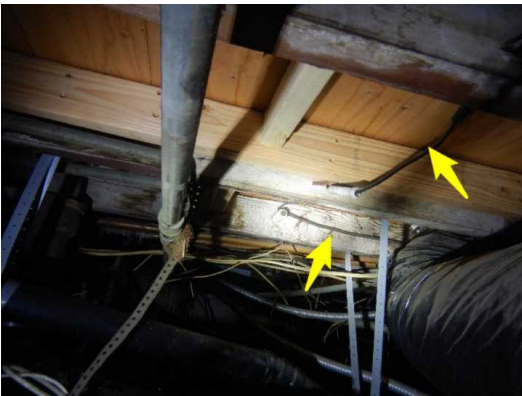
256: Attention needed: There is abandoned cable throughout. We recommend this cable be disconnected at its source or terminated in an approved manner in a covered junction box.

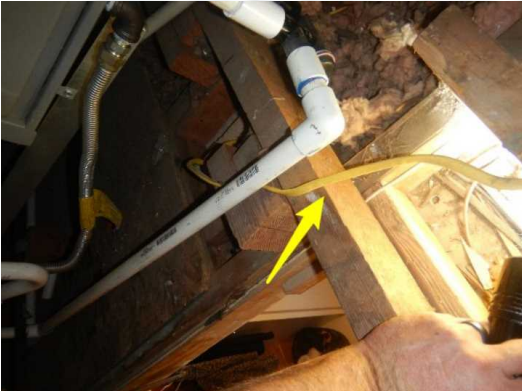
257: Attention needed: Unprotected electrical wires near attic access does not meet clearance requirements.

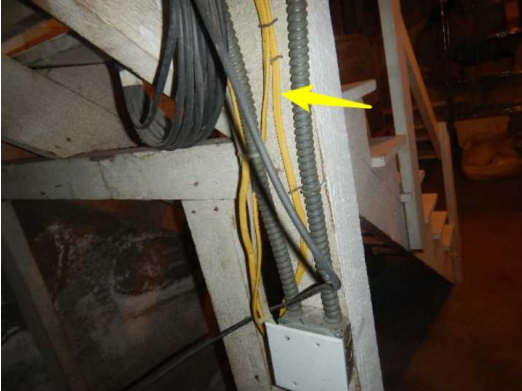
258: Attention needed: There are noted sections of nonmetallic electrical wiring, also referred to as "romex" (This is the white, yellow or grey flexible conduit) in areas improperly installed and prone to damage such as basement.

Have electrician make corrections.

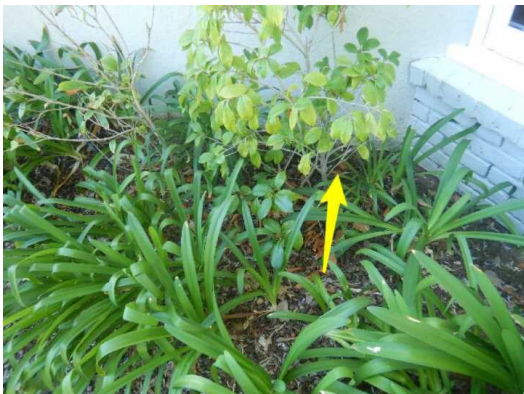
270: Attention needed: The drainage around the foundation needs immediate adjustment in order to divert the run-off water away from the foundation. Ground slope should be adjusted to a rate of at least 1/2 inch per foot for 6 feet away from the foundation.

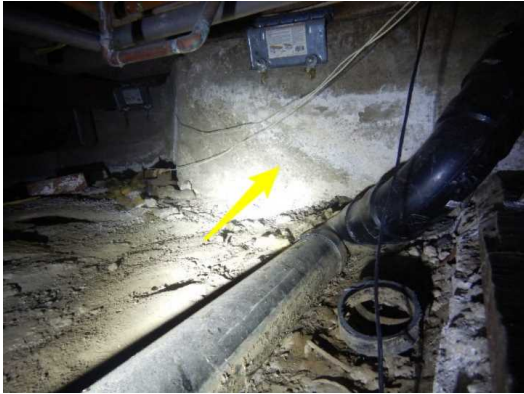
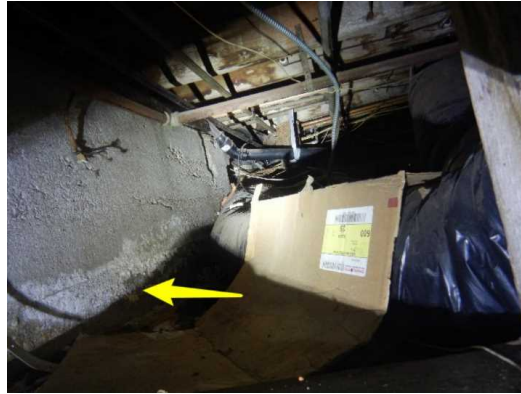
271: Efflorescence noted. (This is the white chalk like substance) is seen on areas of concrete indicating past water infiltration. Corrections are needed to adjacent grade as this can promote decay

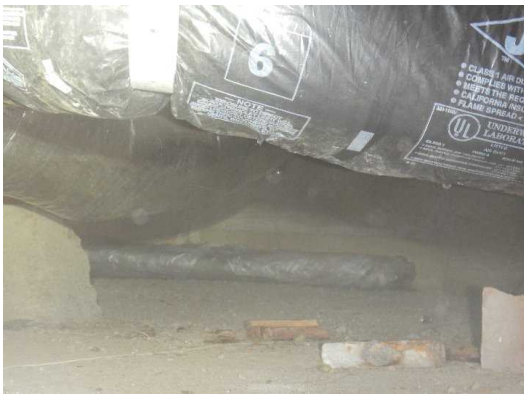
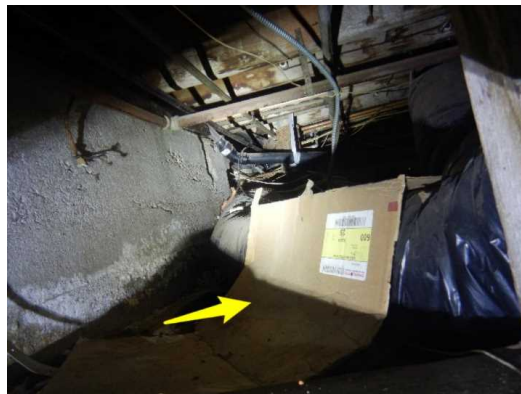
276: Attention needed: There is debris noted in crawl area. Crawl spaces should be clean and free of any debris. Maintenance needed at this time

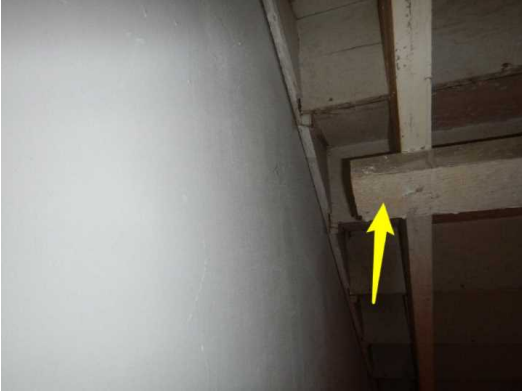
289: Attention Needed - Some portion of the staircase needs attention to perform satisfactorily. Center support cut and not performing. Have licensed framer make repairs.

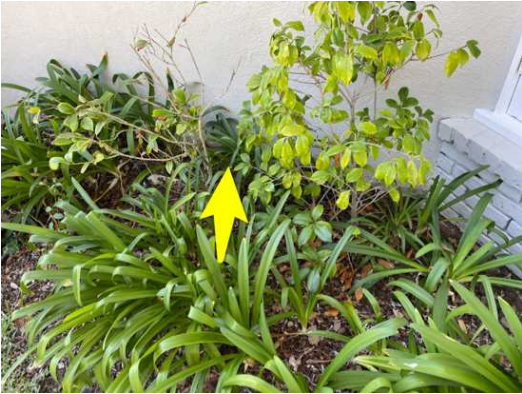
292: Planter box adjacent to structure is not properly flashed. This can be a source of water entry into substrate.

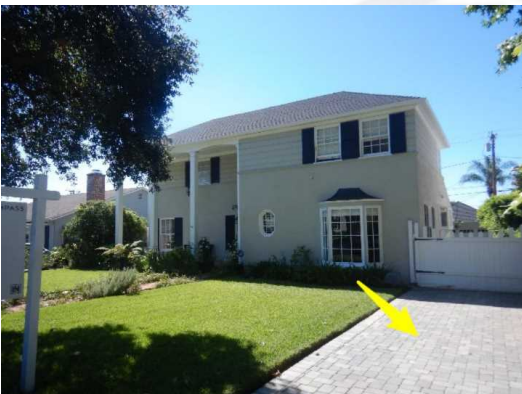
293: Pavers

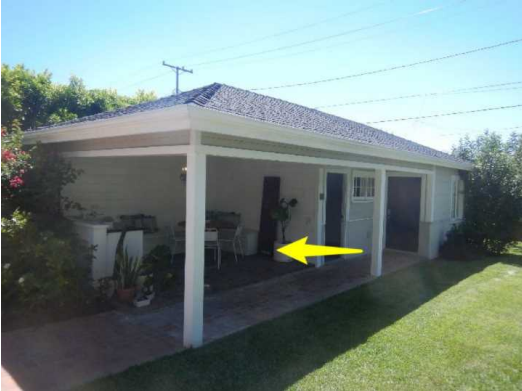
297: Brick.

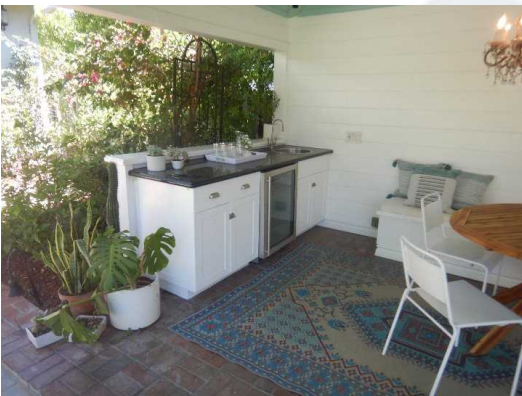
298: Satisfactory

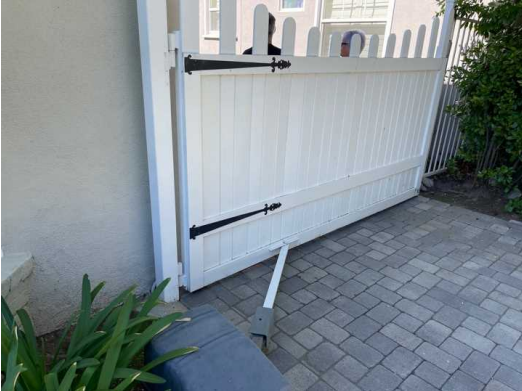
303: Automatic gates are not inspected by this inspection report. These components more than likely do not have child safety reverse safety features. Highly recommend consulting installer for more details and further evaluation as relates to the system.

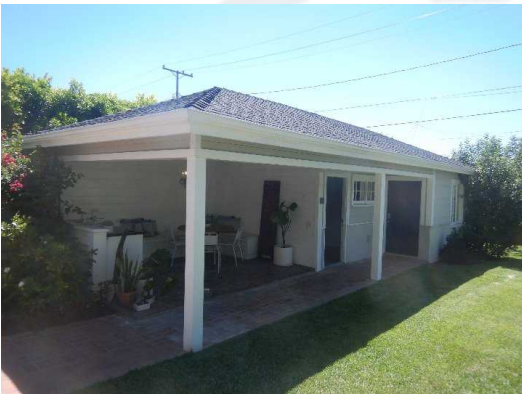
304: Guest house

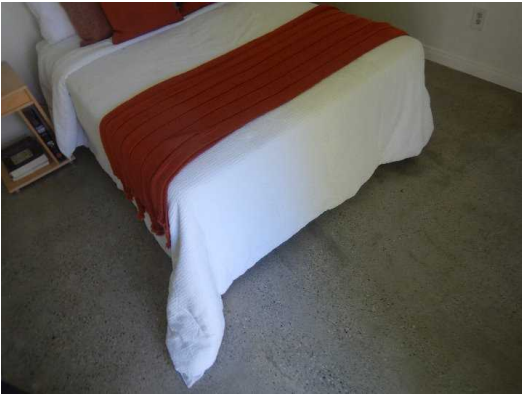
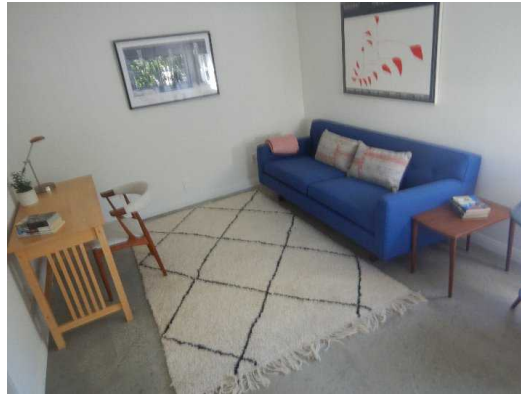
306: Serviceable

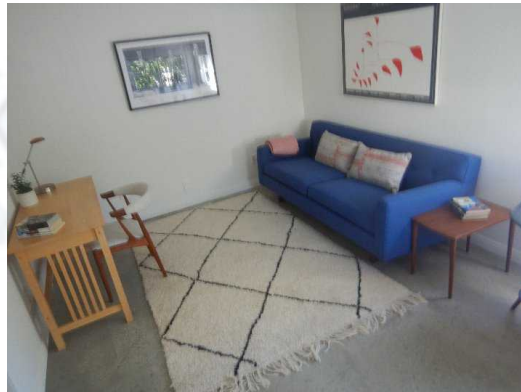
308: Serviceable at visible areas only. Flooring is covered with items, such as carpet and furniture etc.

Finished concrete used as flooring.

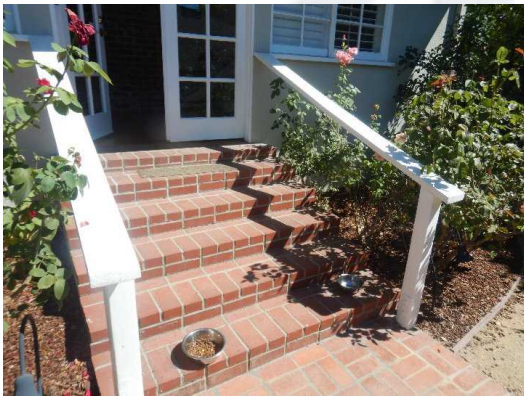
s-47: Attention: Client should be aware that hand railings are not constructed to industry standards. Ideally had rails would allow for easy hand grip.

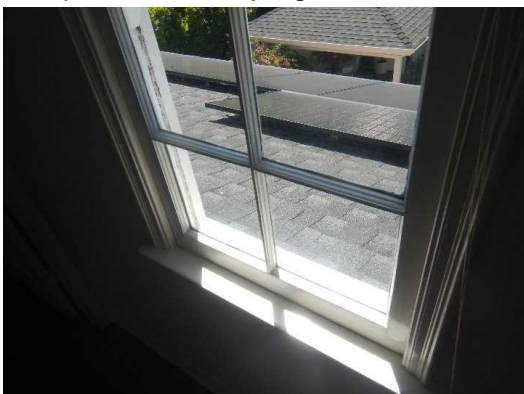
s-87: Some of the windows are painted shut and do not operate. Repairs are needed as this does compromise safety egress and hinder ventilation.

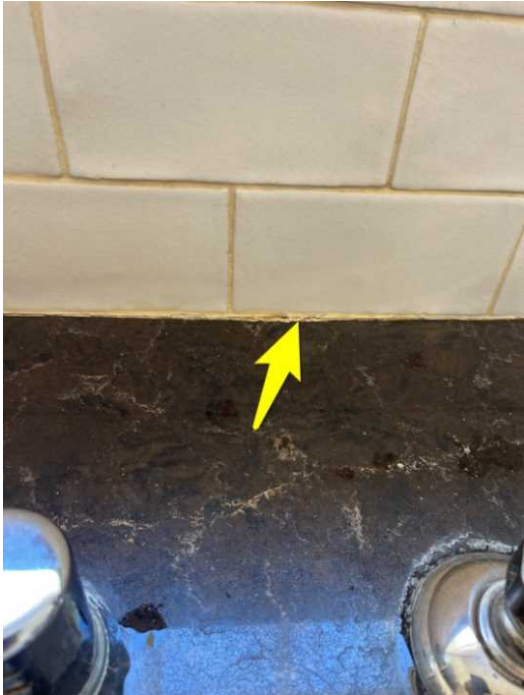
s-103: Attention needed: The caulking in water contact areas appears to need attention, such as along where countertop meets splash wall. If left unsealed, water can cause costly damage.

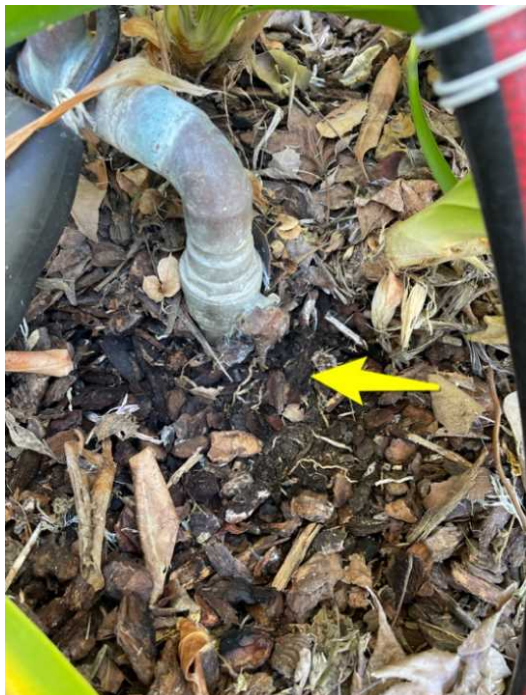
s-159: Main service shut off should be located in an accessible location to facilitate operation in the event of an emergency.

Valve buried in soil. Improvements needed.

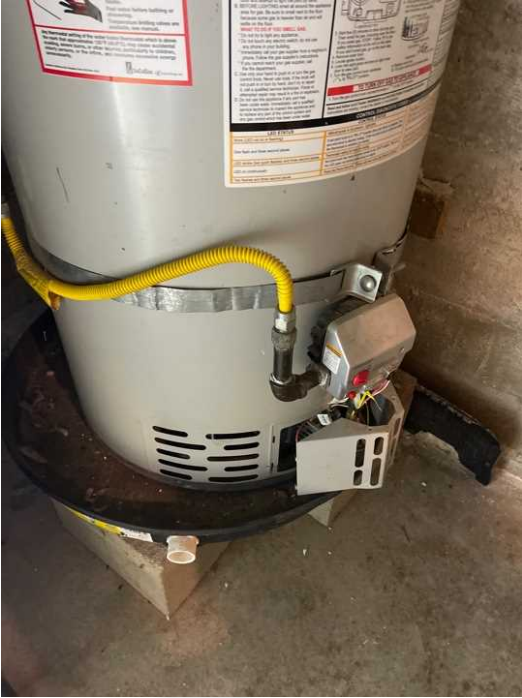
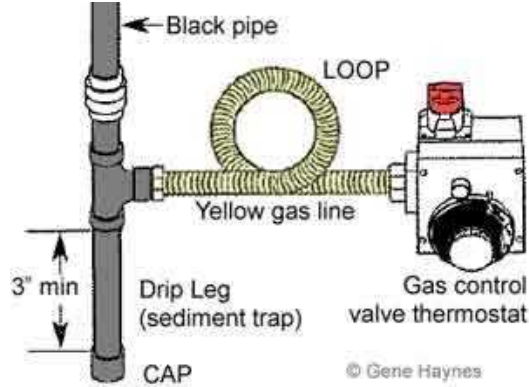
s-178: No - There is no drip leg/sediment trap installed on the incoming gas line to the water heater. Installation of a drip leg is recommended to prevent debris from getting into the gas valve.

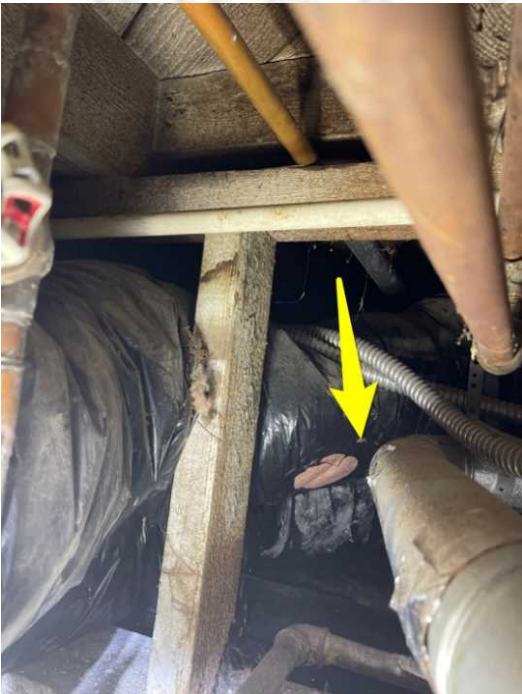
s-180: Unsatisfactory: There is inadequate clearance from flue pipe to adjacent combustible product. Corrections are needed as this is a potential fire hazard. Have licensed plumber remake corrections.

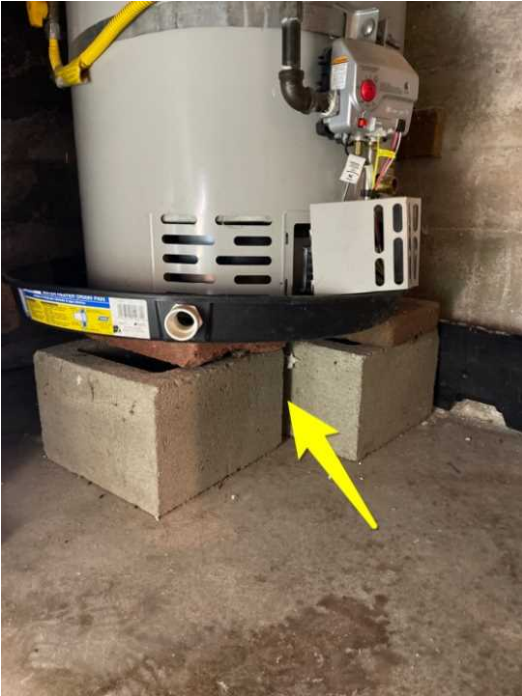
s-188: The platform that this water heater rests on should also be anchored to the structure to prevent movement

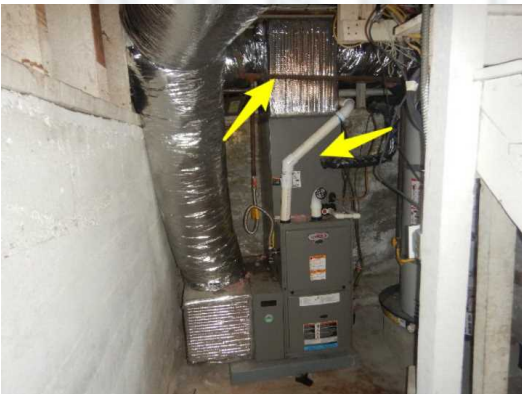
s-202: Attention needed: Water was seek leaking from ducts in lower level crawlspace. Inspector suspects water is coming from interior fan coil. Further evaluation is needed by licensed HVAC technician to its cause.

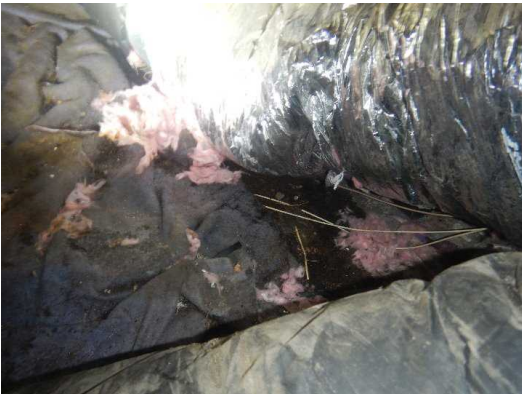
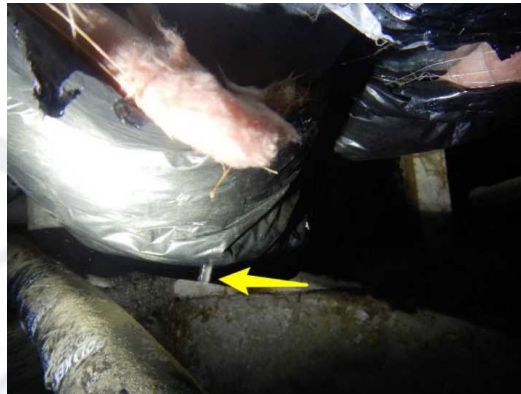
s-220: Unsatisfactory - Some of the ducts for the lower floor need to be replaced due to high water content inside of them. Further evaluation and repairs by licensed HVAC contractor to determine cause of water in ducts.

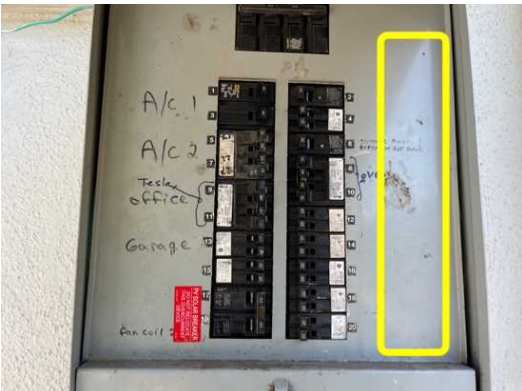
s-245: The breakers are not marked as to the rooms, areas, or appliances controlled. It is recommended that they be noted as soon as possible.

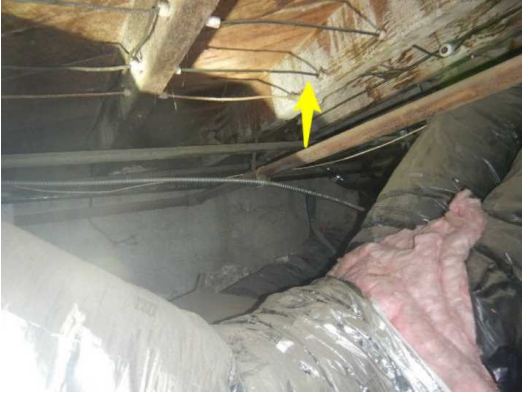
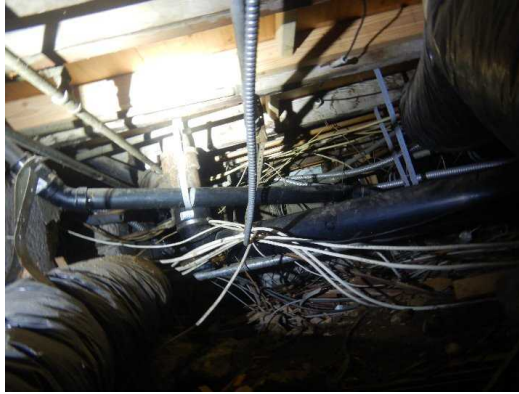
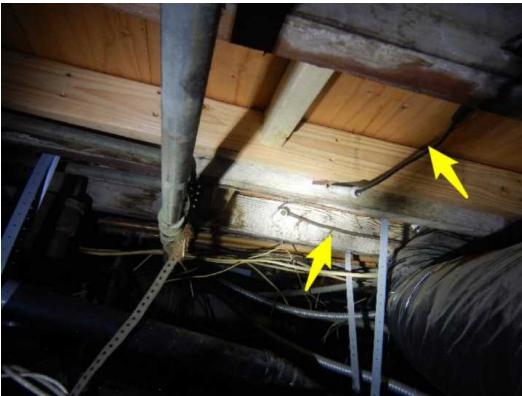
s-256: Attention needed: There is abandoned cable throughout. We recommend this cable be disconnected at its source or terminated in an approved manner in a covered junction box.

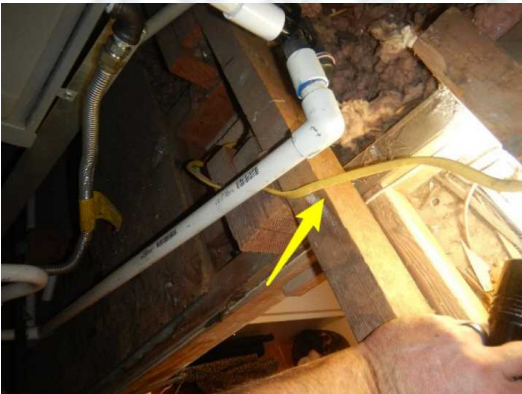
s-257: Attention needed: Unprotected electrical wires near attic access does not meet clearance requirements.

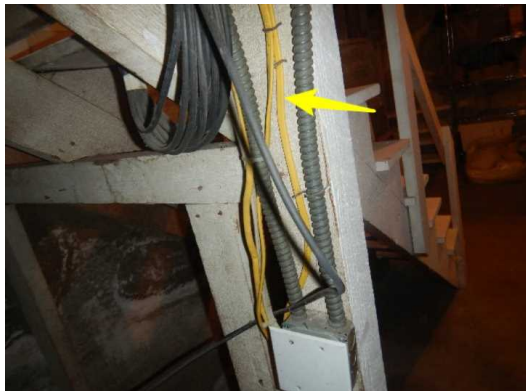
s-258: Attention needed: There are noted sections of nonmetallic electrical wiring, also referred to as "romex" (This is the white, yellow or grey flexible conduit) in areas improperly installed and prone to damage such as basement. Have electrician make corrections.

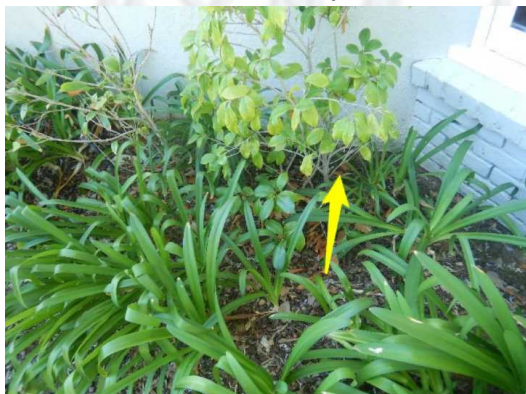
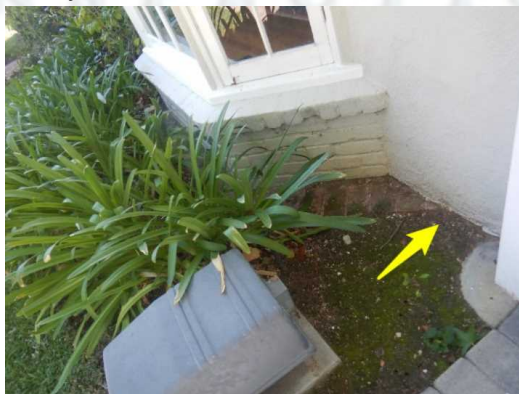
s-270: Attention needed: The drainage around the foundation needs immediate adjustment in order to divert the run-off water away from the foundation. Ground slope should be adjusted to a rate of at least 1/2 inch per foot for 6 feet away from the foundation.

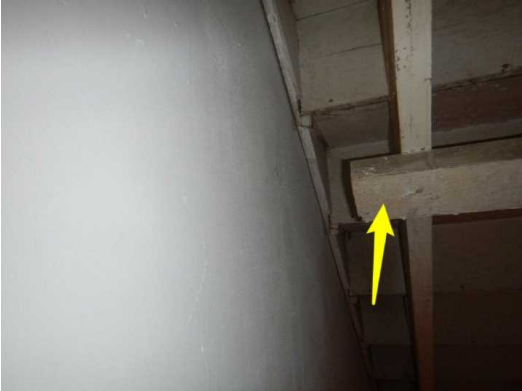
s-289: Attention Needed - Some portion of the staircase needs attention to perform satisfactorily. Center support cut and not performing. Have licensed framer make repairs.
